PROCEEDINGS

OF THE MERCHANT MARINE COUNCIL

Vol. 23, No. 8 • August 1966

IN THIS ISSUE . . .

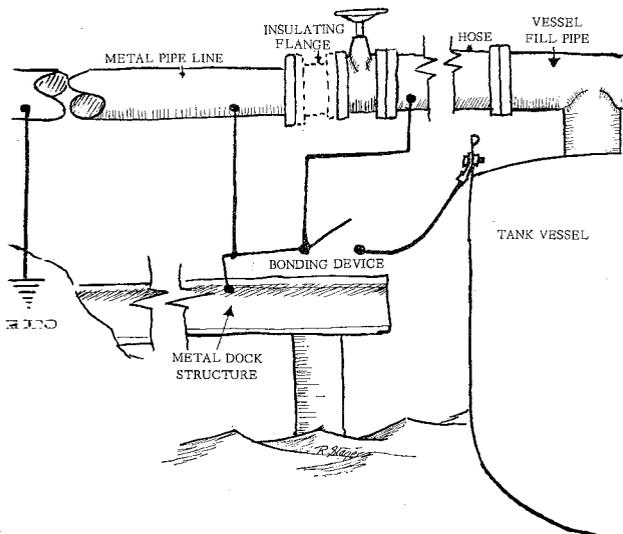
Figure 1—A suggested method of grounding hose, vessel and dock to a common ground to eliminate static charge and stray current. Switch is closed before hose is coupled and opened after hose is decoupled.

Figure 1 shows a common method of connecting a tank vessel to shore. When such a system is used the following sequence for connecting and disconnecting the binding cable and base should be followed:

When connecting: 1. Check to see switch is open. 2. Connect bonding cable to ship. 3. Close switch. 4. Connect cargo base.

When disconnecting: 1. Disconnect and remove cargo base. 2. Open switch. 3. Remove bonding cable.

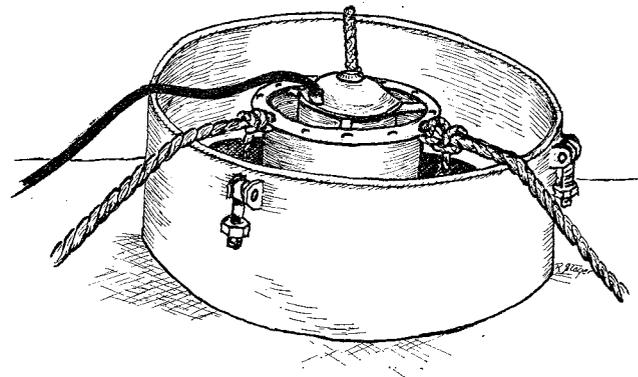
Figure 2—Blower is supported by line in tank opening without grounding. Static charge of dangerous value can develop on motor frame.

Examples of gas type discharges found on shipboard are steam smothering or clear-out lines, carbon dioxide nozzles, ventilation systems and sand blasting. For all of these systems the static accumulation can be reduced or eliminated by proper grounding of the discharge pipe. Figure 2 shows an example of a blower used to venti-

late a tank during gas freeing operations. The blower housing is completely isolated from the barge and could accumulate quite a large charge. Just such an arrangement was used on a barge involved in a tank explosion in which the cause was not specifically established. A simple bonding strap between the fan housing and the barge structure would have eliminated static sparking as a possible cause.

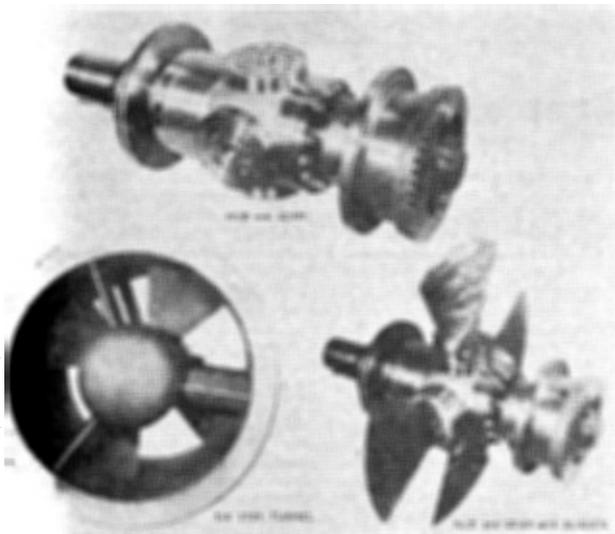
Figure 3.—Bow thruster tunnel, hub, gear and blades.

a shaped casting fitted at each end and faired into the line of the hull. Six stays extend radially inward to support a removable gear drive and a single 79" four bladed propeller with its hydraulic pitch changing and control mechanism (see figs. 1 & 2).

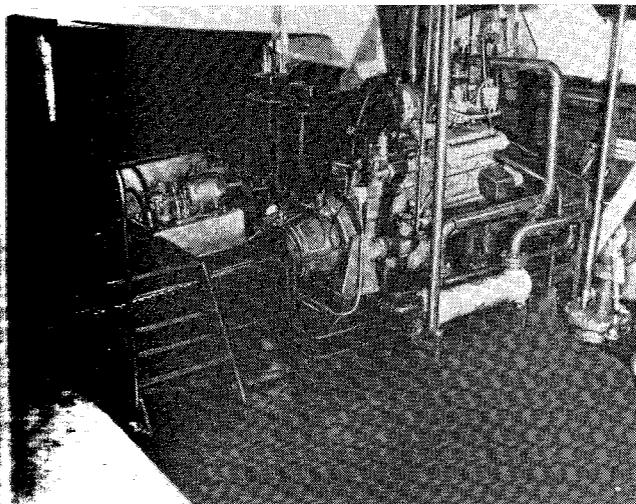
View in Thruster Room on M/S Henry Ford II, showing 500 H.P. Cummins Diesel engine that drives the bow thruster. A portion of the tunnel appears lower left in picture. Hydraulic system that delivers oil to propeller pitch changing mechanism is housed in control box just to left of engine.
