# PROCEEDINGS OF THE MERCHANT MARINE COUNCIL UNITED STATES COAST GUARD

July 1953

**DECK TO DOCK OR DOCK TO DECK—MAKE IT SAFE**

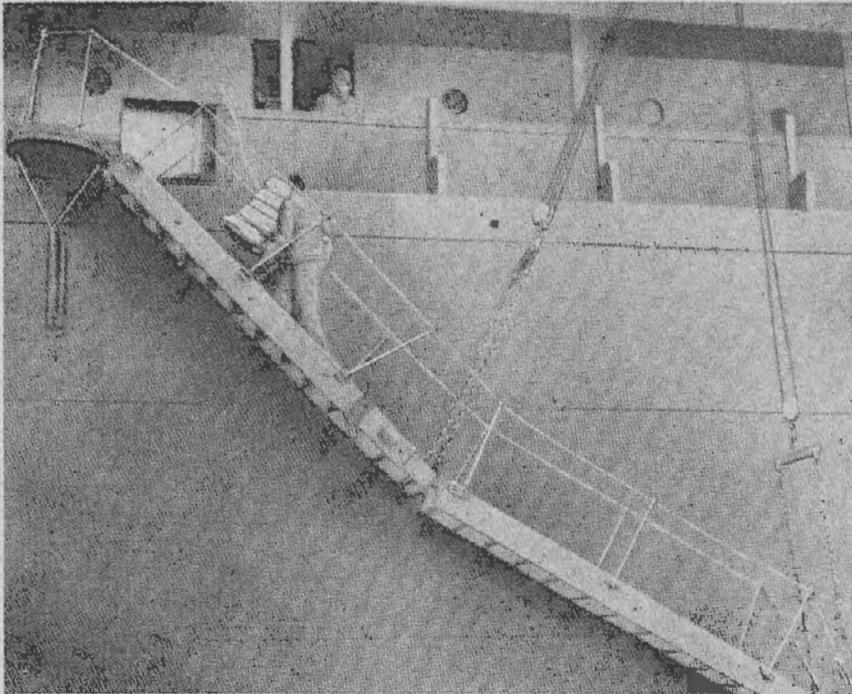
This is a picture of the way a gangway should not be rigged. It is also a picture of the way not to cross a gangway. Note the stanchions are loose and not properly secured.

Note the loose one-course hand rope.

Note the lack of sure footing due to the treads being canted from a reasonably horizontal position.

Note the man walking up the ladder is apparently violating two important safety rules. First, he cannot see where he is stepping. Second, both of his hands are engaged with the load he is carrying.
