# PROCEEDINGS

OF THE MERCHANT MARINE COUNCIL

Vol. 17, No. 1 • January 1960

# REVIEW OF MARINE CASUALTIES

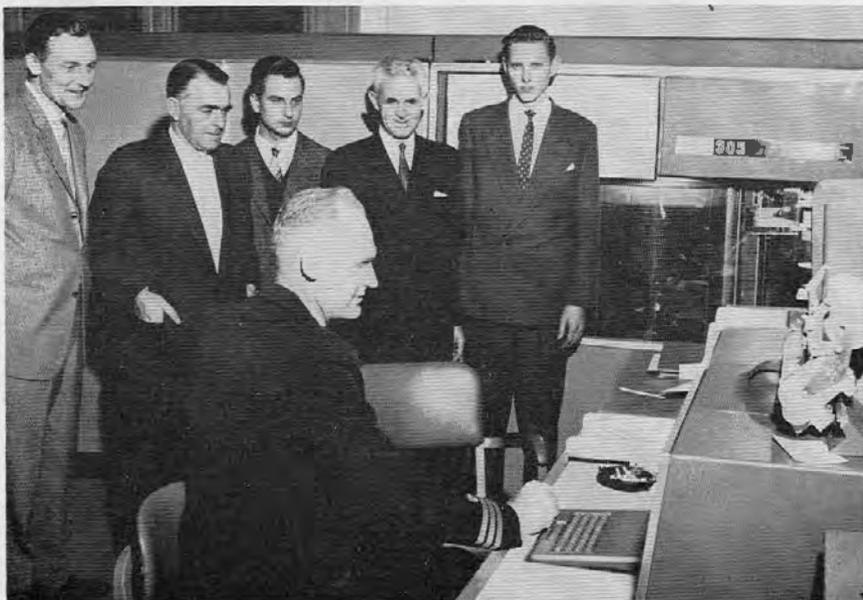
**CAPTAINS AND CREW** members of three merchant vessels visited the Coast Guard ships plot center at the Commander, Eastern Area Office, in the Custom House, New York City, recently. They were shown the magnetic "memory" where the reported or calculated positions of more than 600 merchant vessels then underway in the North Atlantic Ocean were stored.

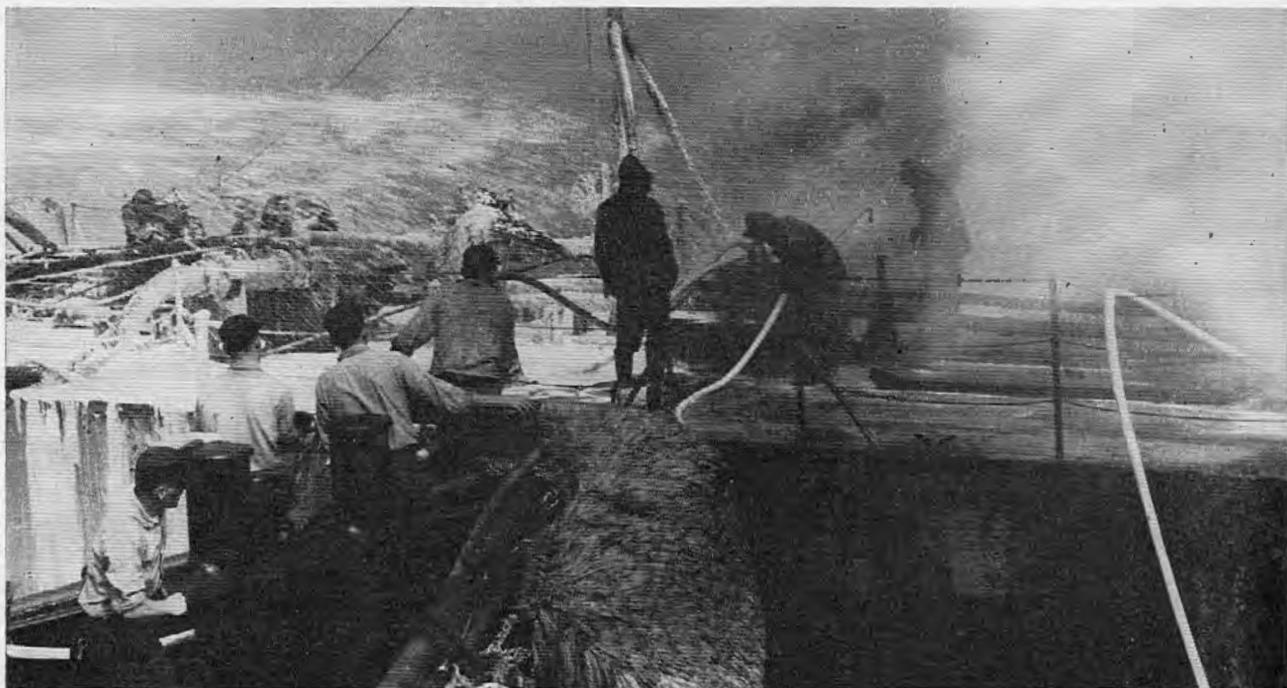
THE TANKER *S. E. Graham*, fully loaded with gasoline, exploded and burst into flames after colliding with the tanker *S.S. Gulfoil* in the East Passage of Narragansett Bay, Newport, R.I. Hose carrying chemical foam pumped from a Navy Tug are placed into the open tank hatches of the *Graham* by a boarding party of firefighters, in the picture above.

escape and probably ignite through the impact. In the almost instantaneous fire which engulfed both vessels the crews were driven overboard and 17 crew members, among them the Master, of the *Gulfoil* were known to have lost their lives. Their bodies were recovered but one other disappeared and is presumed dead. Others of the *Gulfoil* crew suffered varying degrees of injury through burns and immersion, while those from the *Graham* escaped relatively unscathed.

Damage to the *Gulfoil* was reported to be in excess of \$1 million. The *Graham* was considered a total loss with damage amounting to approximately \$500,000 and \$100,000 to her cargo.

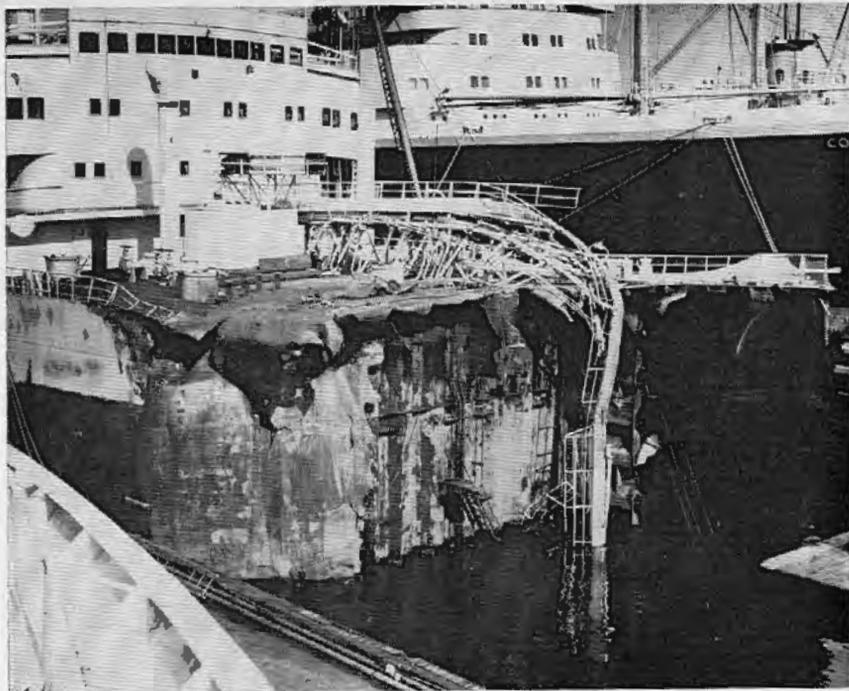
The bow of the *Constitution* almost completely severed the bow of the *Jalanta* forward of her pilothouse and approximately 25 minutes later the bow finally broke off. Considerable hull damage was sustained by the bow of the *Constitution*; miraculously, however, since the *Jalanta* was not gas free, there was no fire or explosion and there were no lives lost and no injuries to any persons.

The bow of the *Constitution* almost completely severed the bow of the *Jalanta* forward of her pilothouse and approximately 25 minutes later the bow finally broke off. Considerable hull damage was sustained by the bow of the *Constitution*; miraculously, however, since the *Jalanta* was not gas free, there was no fire or explosion and there were no lives lost and no injuries to any persons.

avoided, but only because the *Jalanta* maintained the same course throughout. In weighing the merits of the radar plot in this case we must not lose sight of the fact that the *Jalanta* could have changed course at any time and had she done so after the sea return obscured the *Constitution's* scope any information gleaned from previous plotting would have been useless. The principal fault, however, was the excessive speed and failure to stop when the fog signals of the *Jalanta* were heard forward of the beam. Had the requirements of the law been adhered to in this case the collision would never have occurred.

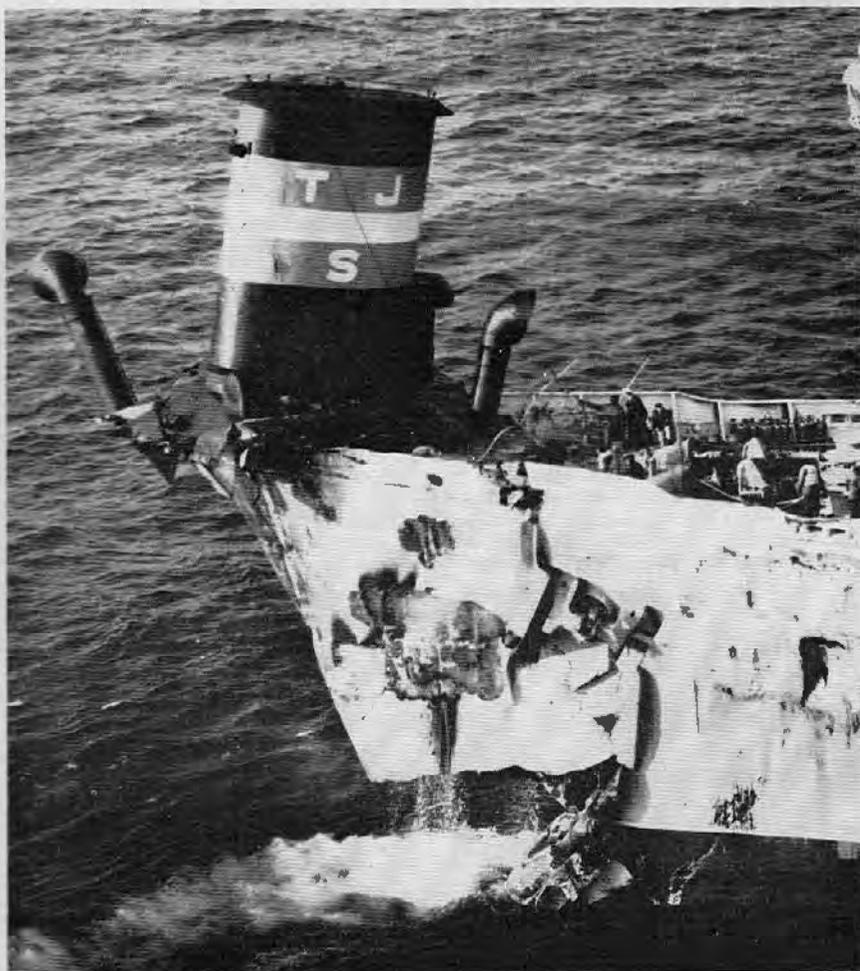
A closeup view of the bow of the *Santa Rosa* carrying the stack and adjacent ventilators from the tanker *Valchem* after a collision 22 miles east of Atlantic City, N.J.

The second case involved the *Santa Rosa* and the tanker *Valchem*. This collision occurred at 0301 e.s.t., 26 March 1959. The failure to comply with the Rules of the Road once again accounted for the loss of 4 lives, injuries to 21 persons, and nearly \$2,000,000 in property damage.

In this casualty as in the previous case, the principal cause was violation of the International Rules—specifically immoderate speed and failure to stop when a fog signal was heard forward of the beam.

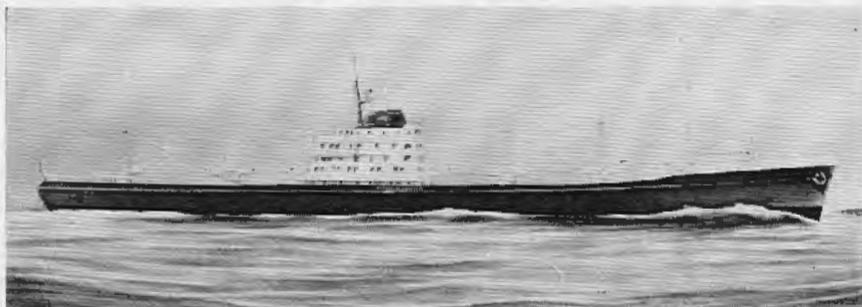
## NEW PFE SHIPS

A \$27,346,000 contract for construction of two cargo ships was signed by Pacific Far East Lines, Inc., of San Francisco, owner; Bethlehem Steel Co., Shipbuilding Division, Pacific Coast District, builder; and the Federal Maritime Board. The vessels, part of a nine-ship program, will be

of the basic Mariner type, 565 feet in length with a 76-foot beam. Modifications to the standard design will consist of additional deep tank and reefer space, bulk unloaders, lift-on lift-off features, and advanced safety and navigation features.

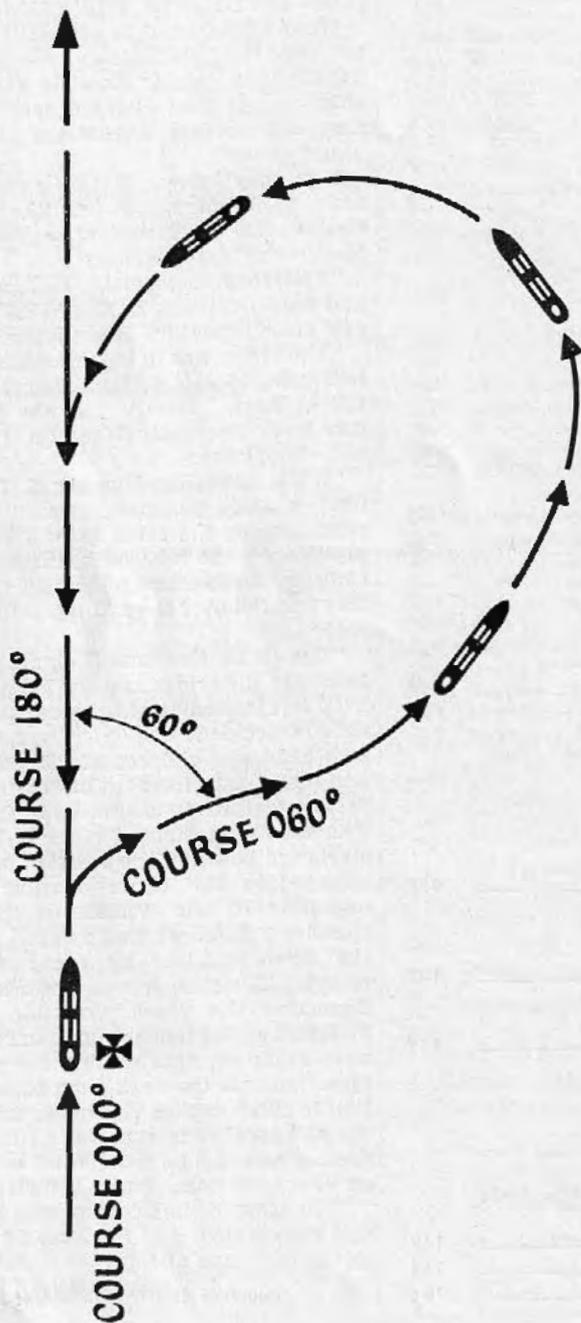
# Instructions for Completing the 'WILLIAMSON TURN'

✠ Spot where man fell overboard.

Depending on which side the man falls overboard put the rudder hard over to that side to swing the stern away from the man. Hold the rudder hard over until she is swinging then steady her up on a course about 60° off the original course.

When vessel heads on new course, swing rudder hard over to the other side until vessel is on a reverse course 180° from original course.
