PROCEEDINGS

OF THE MERCHANT MARINE COUNCIL

Vol. 20, No. 7 • July 1963

FAILURES IN WIRE ROPE

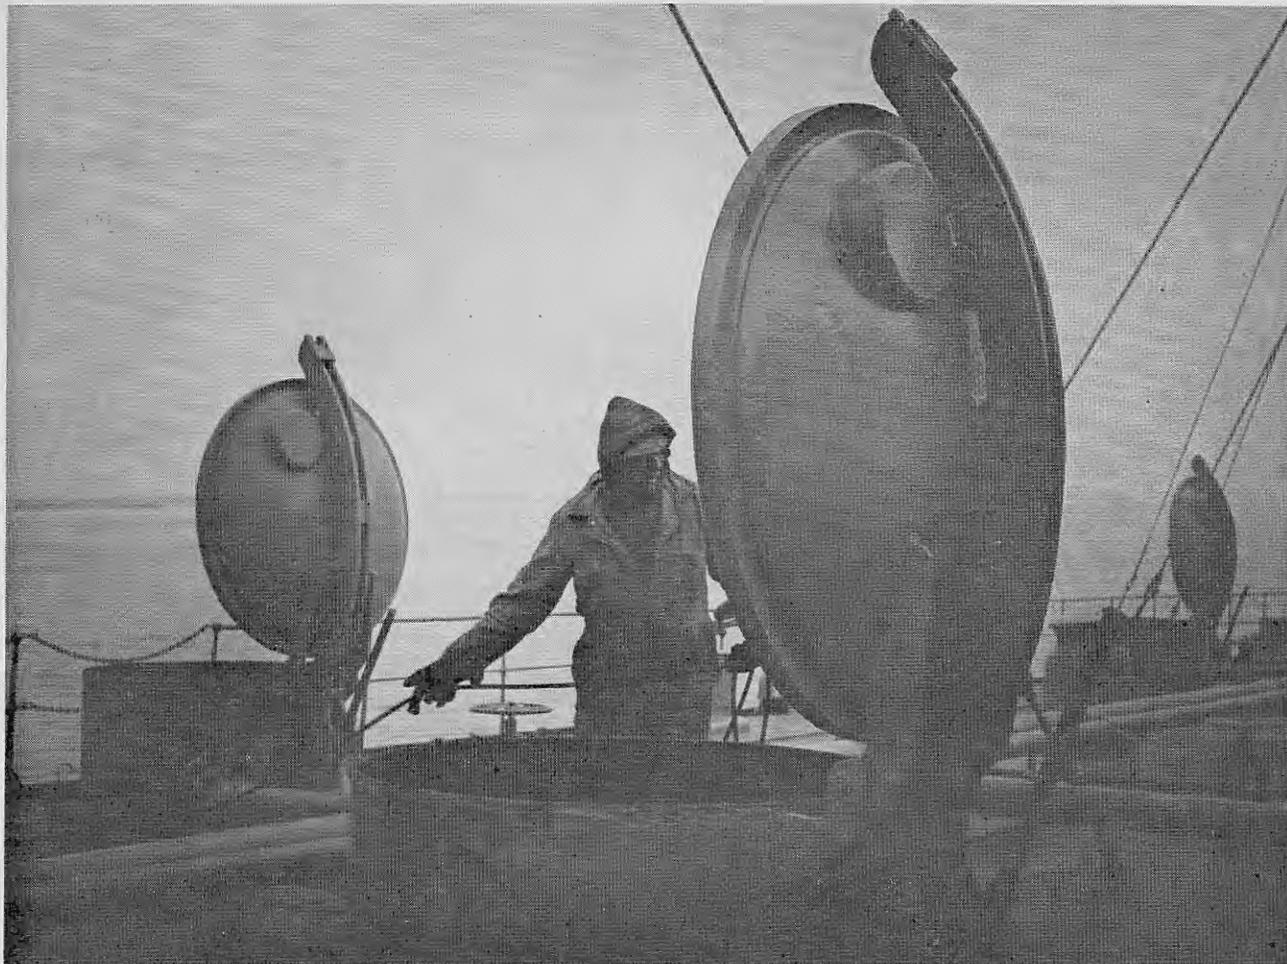
EVER MINDFUL of safe practices, a seaman stands guard at an open tank top aboard the Sun Oil Co.'s tanker SS *Ohio Sun*. Below, a team of shipmates are cleaning the tank recently emptied of crude oil.

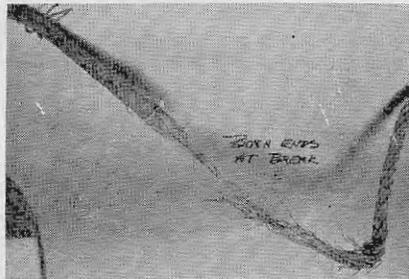
PHOTOGRAPH of wire rope boat fall which parted in service—showing portion of the wire at the point of failure.

Failures in these wire rope falls occurred at points where the falls were stationary over their davit sheaves. Except for the times during drills, lifeboats on a ship are stowed up on davits with their falls taut and at certain points the falls are in continuous contact with the davit sheaves. These contact points in the wire rope are under pressure from the sheaves and have their lubrication squeezed from the wire strands.

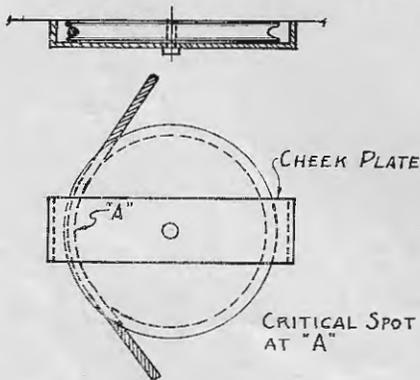
TYPICAL BLIND SHEAVE

On the exposed portions of the wire rope falls, a ship's crew can apply lubrication without lowering the lifeboats. But in spots where the falls are inside of blind sheaves there are places that cannot be reached without lowering the lifeboats and exposing the wire rope. In these places the sheaves are partly covered by steel cheek plates, and a seaman trying to apply oil or slush can't get behind the cheek plates with his brush or swab. Even if the wire rope is clear of a cheek plate, he will not be able to lubricate the side of the wire rope riding tight against the sheave.

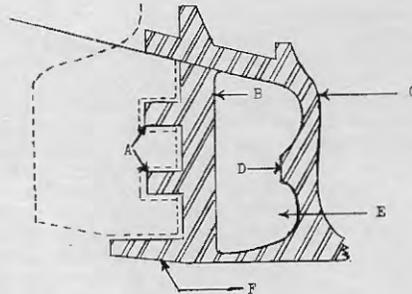
Q. Name the parts of the stern frame sketched below which are marked A, B, C, D, E, and F.

- A. A=Gudgeons
B=Rudder Post
C=Propeller Post
D=Boss
E=Propeller Aperture
F=Skeg
