**U.S. Coast Guard**
Marine Safety Office,
Portland, Maine

This diagram was prepared as part of case number MC97003192, injury onboard a scallop dragger, March 4, 1997 off Stonington, Maine

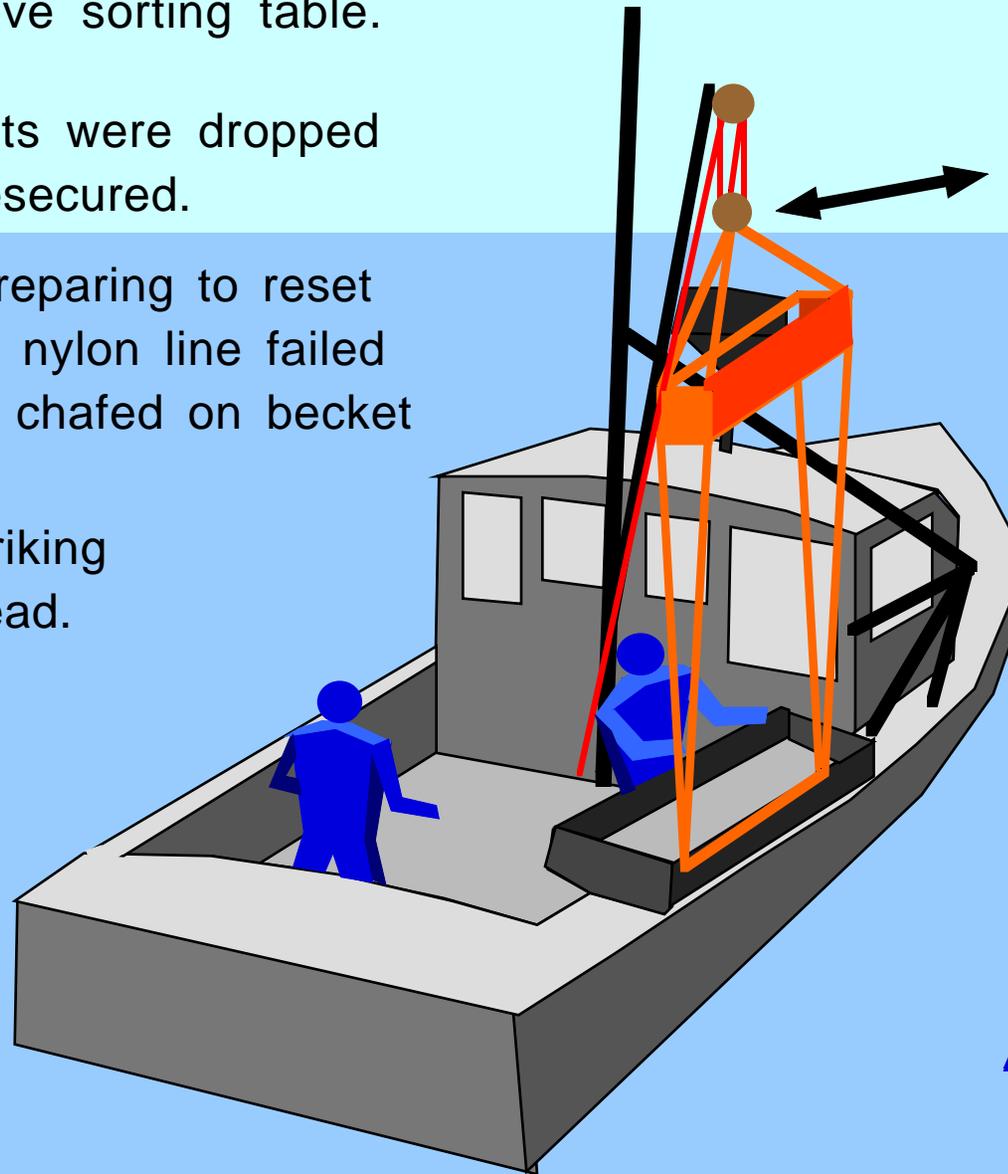
1. Crew had recovered drag and suspended above sorting table.

2. Drag contents were dropped and club bar resecured.

3. Crew was preparing to reset drag when 3/4" nylon line failed where eye had chafed on becket of tail block.

4. Drag fell, striking crewman on head.
