Positive Pressure Test of Casing

Negative Pressure Test of Casing

Kick Detection

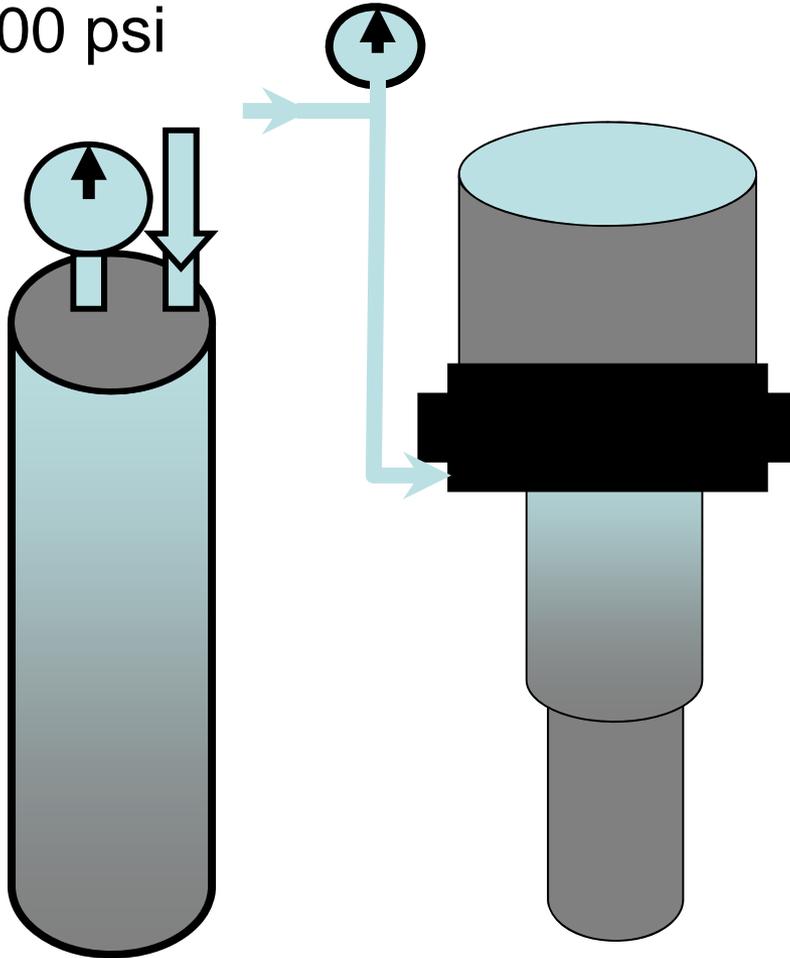
Pumped in 5 bbl,
Pressure increased to
2500 psi

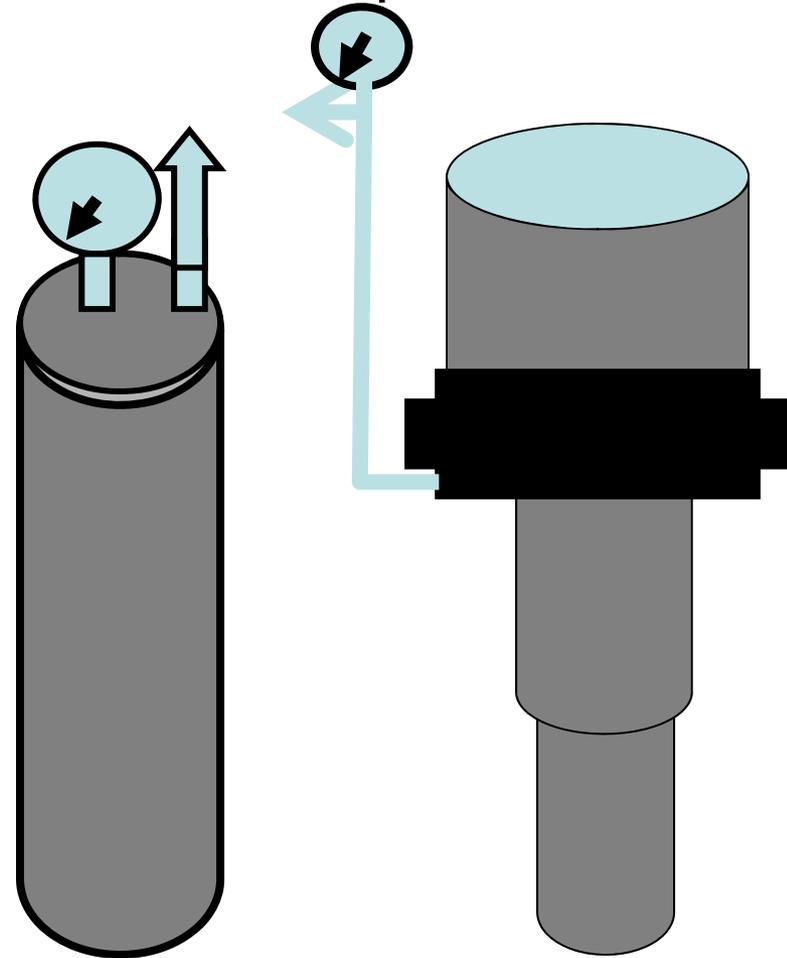
Bled off 5 bbl, Pressure
decreased to 0 psi

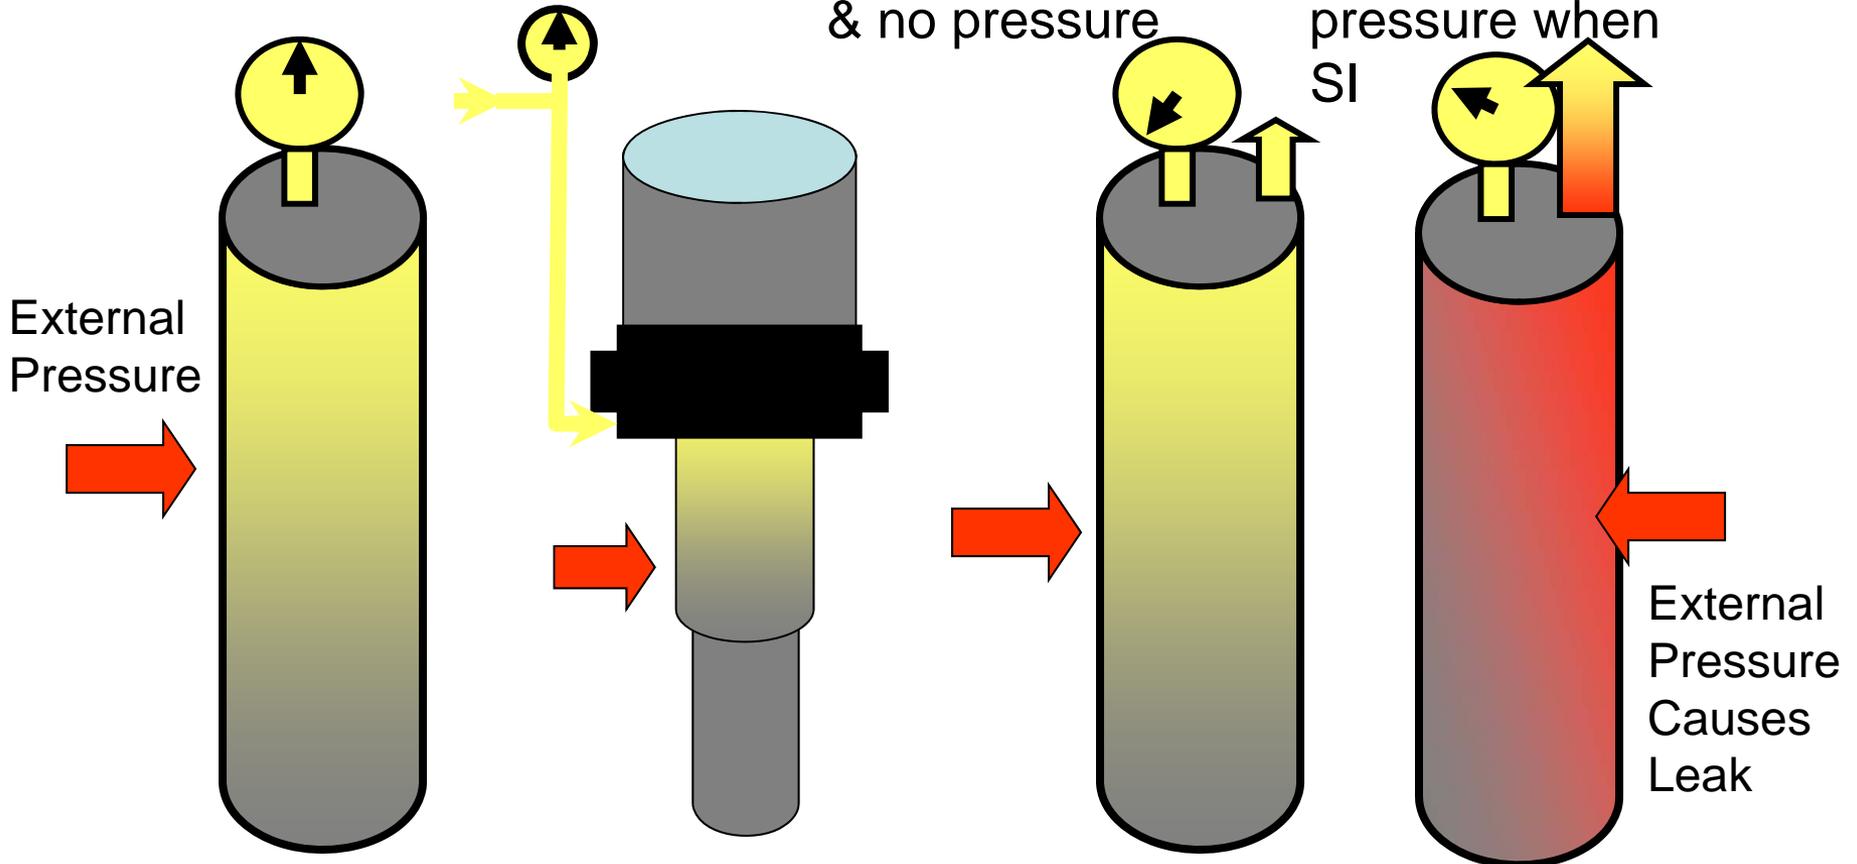
Plan: Partially replace mud with seawater, leaving seawater in choke & kill lines & drillpipe. Bleed off pressure on seawater to 0 psi.

Success – Bleed 5 bbl & stops, SI & no pressure

Failure – Bled 15 bbl & Built pressure when SI
