## *Intrepid*, 1963

CG-52315

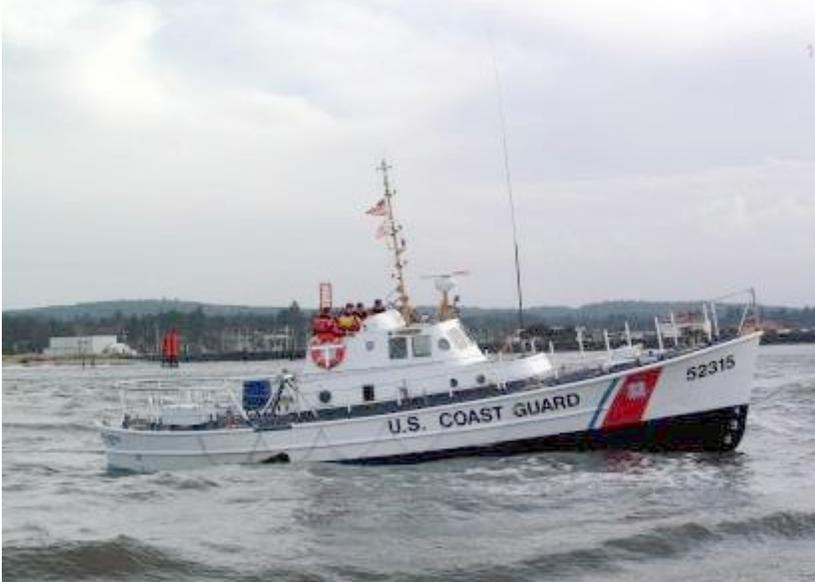
Builder: Coast Guard Yard, Curtis Bay, Maryland

Length: 52'

Beam: 14' 7"

Draft: 6' 11"

Displacement: 75,715 pounds

Machinery: 2 General Motors; twin propellers

The steel-hulled 52-foot motor lifeboat was designed for offshore rescue under the worst sea conditions. They are self-righting and self-bailing and can carry up to 40 survivors. They were designed by the Coast Guard to replace the 52-foot

The 52-footers are constructed of steel. Among other features that increase their range and endurance, the craft is fitted with a complete galley. The boat is equipped with 250-gallon-per-minute pump for dewatering and fire fighting. These are the only Coast Guard vessels under 65-feet in length with names, a tradition started beginning with their 52-foot wooden hulled predecessors. Beyond the search and rescue mission, they are also assigned to maritime law enforcement, marine environmental protection, and recreational boating safety duties.

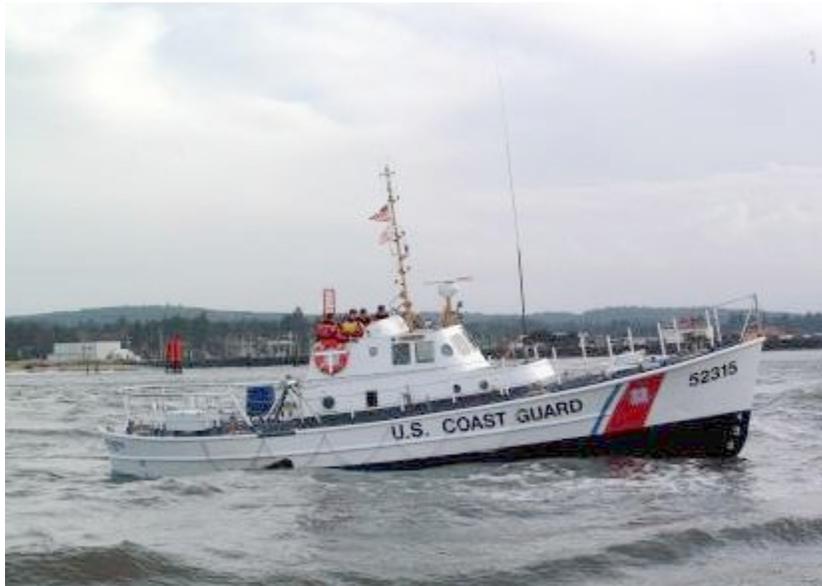
"Coast Guard 52-foot motor lifeboat *Intrepid* (Station Coos Bay), which is one of the four used in the Coast Guard. These boats are built to withstand the most severe conditions at sea and are capable of effecting a rescue at sea even under the most difficult circumstances. They are self-bailing, self-righting, almost unsinkable and have a long cruising radius. The crew of the *Intrepid* recently rescued a couple who were aboard a 65-foot sailboat, *Broken Hobbles*, in distress off Point Blanco, Oregon."; 20 December 2002; CG Photo No. 021220-C-4178J-500 (FR); photo by PA3 Anthony Juarez, USCG.

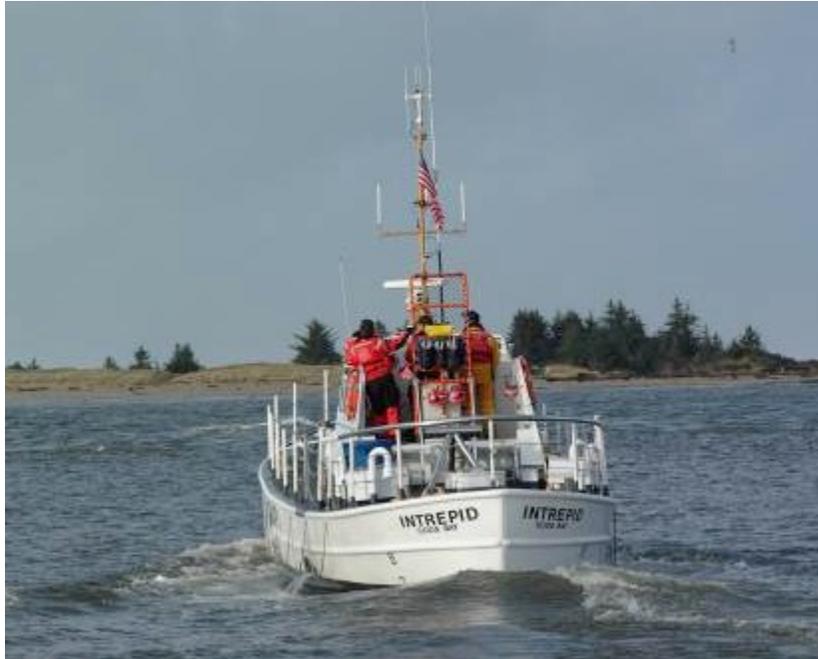
"Coast Guard 52-foot motor lifeboat Intrepid (Station Coos Bay), which is one of the four used in the Coast Guard. These boats are built to withstand the most severe conditions at sea and are capable of effecting a rescue at sea even under the most difficult circumstances. They are self-bailing, self-righting, almost unsinkable and have a long cruising radius. The crew of the Intrepid recently rescued a couple who were aboard a 65-foot sailboat, Broken Hobbles, in distress off Point Blanco, Oregon."; 20 December 2002; CG Photo No. 021220-C-4178J-506 (FR); photo by PA3 Anthony Juarez, USCG.

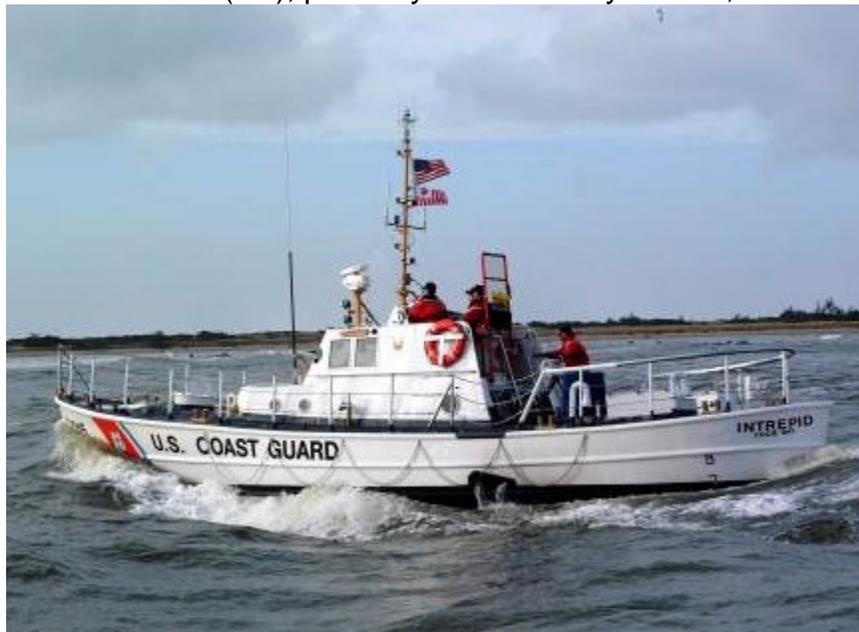
"Coast Guard 52-foot motor lifeboat Intrepid (Station Coos Bay), which is one of the four used in the Coast Guard. These boats are built to withstand the most severe conditions at sea and are capable of effecting a rescue at sea even under

the most difficult circumstances. They are self-bailing, self-righting, almost unsinkable and have a long cruising radius. The crew of the Intrepid recently rescued a couple who were aboard a 65-foot sailboat, Broken Hobbles, in distress off Point Blanco, Oregon."; 20 December 2002; CG Photo No. 021220-C-4178J-504 (FR); photo by PA3 Anthony Juarez, USCG.

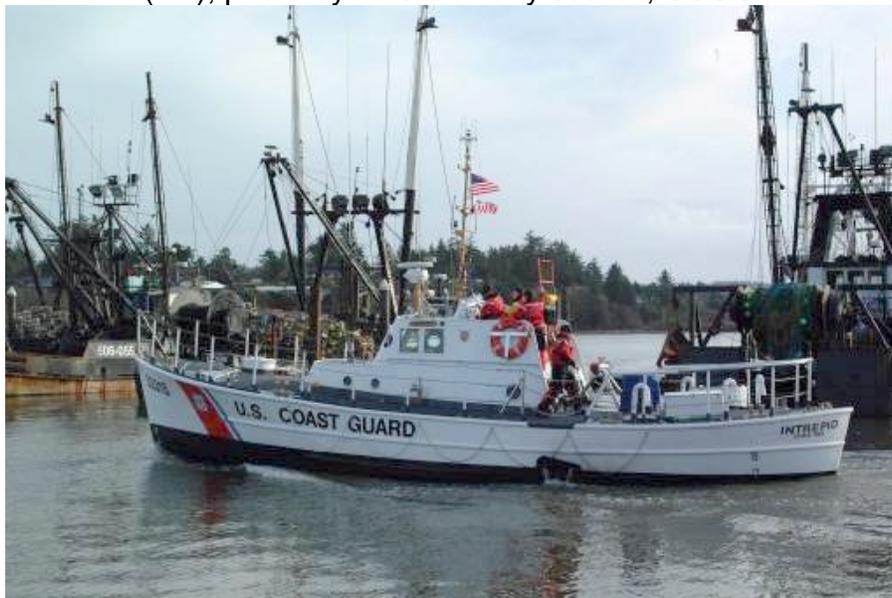
"Coast Guard 52-foot motor lifeboat Intrepid (Station Coos Bay), which is one of the four used in the Coast Guard. These boats are built to withstand the most

severe conditions at sea and are capable of effecting a rescue at sea even under the most difficult circumstances. They are self-bailing, self-righting, almost unsinkable and have a long cruising radius. The crew of the Intrepid recently rescued a couple who were aboard a 65-foot sailboat, Broken Hobbles, in distress off Point Blanco, Oregon."; 20 December 2002; CG Photo No. 021220-C-4178J-510 (FR); photo by PA3 Anthony Juarez, USCG.

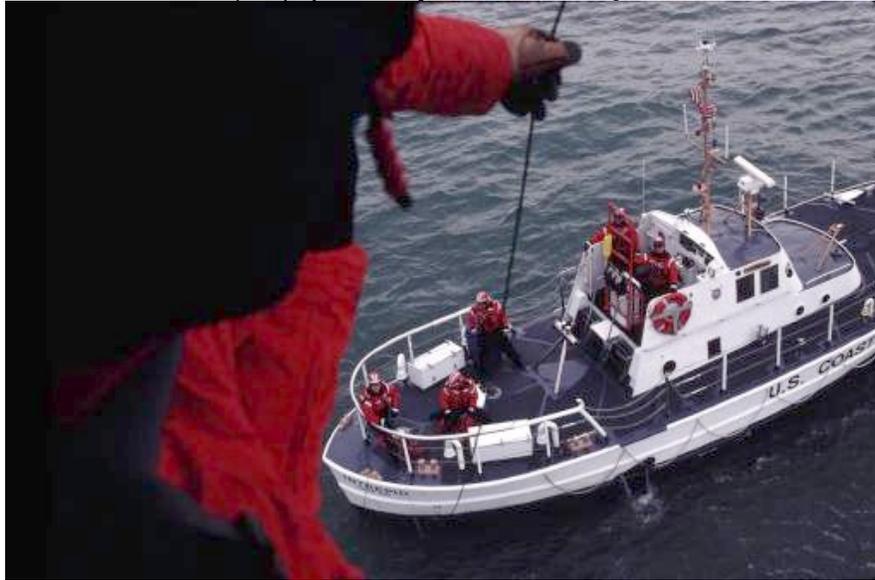
"An AST maneuvers a hoist cable over 52-foot motor life boat Intrepid from Station Coos Bay, Ore. Coast Guard crews continually train to maintain skills in preparation for real-life cases."; 11 January 2002; CG Photo No. 020111-C-7609S-501 (FR); photo by PA2 Sarah Foster-Snell, USCG.

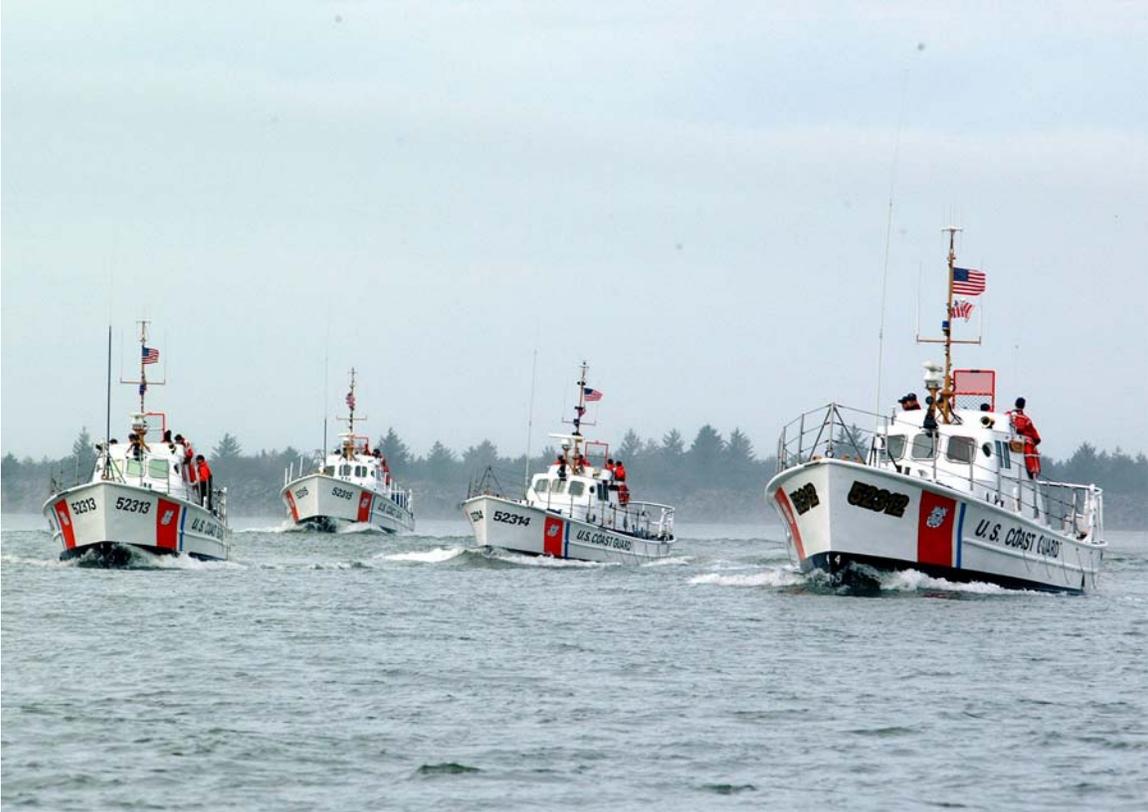
"The Coast Guard's four remaining 52-foot motor lifeboats, Invincible II, Intrepid, Triumph II and Victory get underway together for the first time since 1998 at Station Cape Disappointment, WA. Feb. 13, 2003. The 52-foot motor life boats are widely used in support of search and rescue, maritime law enforcement, marine environmental protection and recreational boating safety."; 13 February 2003; CG Photo No. 030213-C-3652F-506 (FR); photo by PA3 Kurt Frederickson, USCG.
